# **Seismic Damage Assessment and Soft-Story Response Mechanisms in a Reinforced Concrete Mid-Rise Building Following a Doublet Earthquake Sequence**

Lessons Learned for Post-Earthquake Structural Assessment and Seismic Resilience

**June 24, 2026 | Venezuela Seismic Event**

**July 2026 | Technical Report**

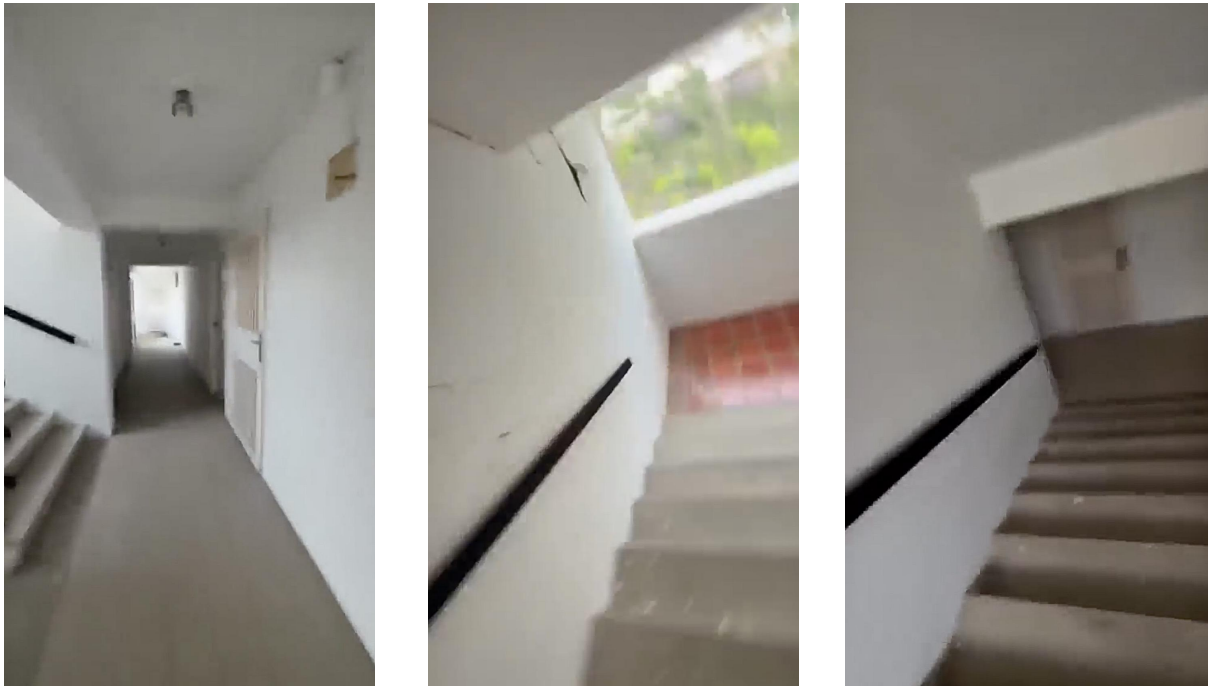
Video stills captured at the upper story levels did not reveal evidence of significant structural or nonstructural damage. Corridor walls and stairwell enclosures appeared intact, with clean floor surfaces and no visible debris accumulation. A single hairline diagonal crack observed at a wall-to-slab interface represented the only visible feature potentially associated with seismic demand at this level. Door frames appeared to remain plumb, with no visible evidence of significant distortion. These observations were generally consistent with visual damage conditions commonly associated with the

Immediate Occupancy (IO) performance level described in ASCE 41-17, Section 2.3.1.1 and Table 2-3 (ASCE 2017).

**Figure 1:** Representative condition of upper stories showing intact finishes, minor hairline cracking, and lack of debris accumulation.

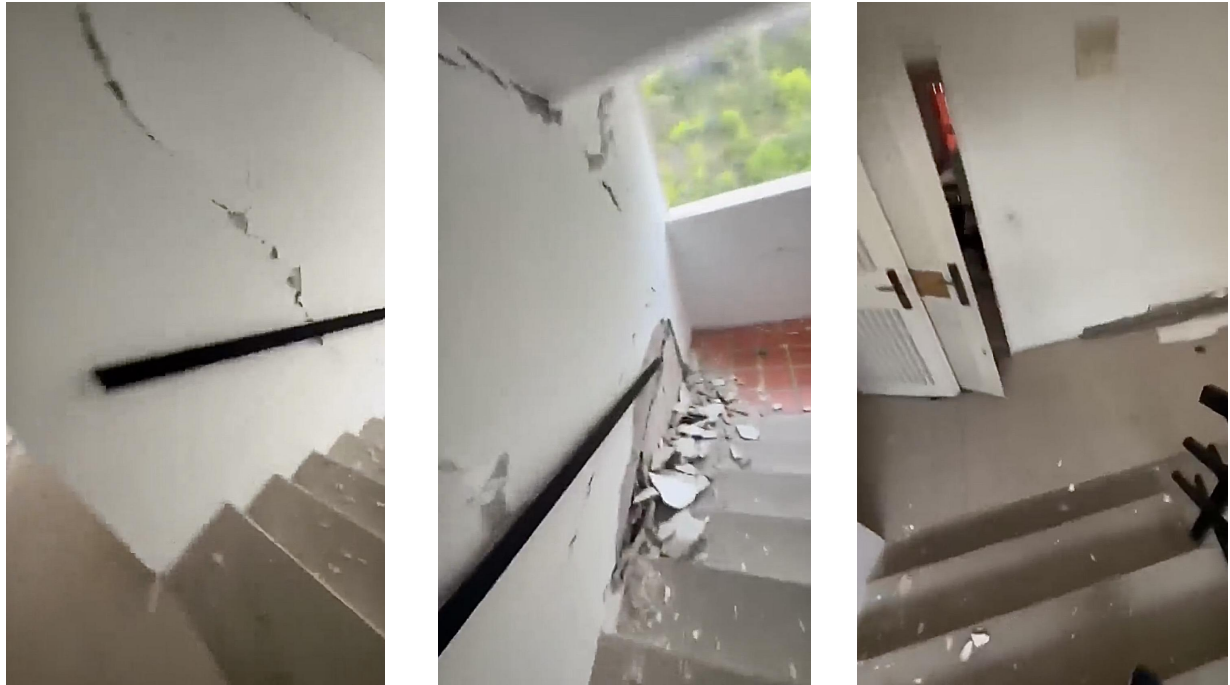
As the occupant descended toward the mid-level floors, video stills documented a progressive increase in damage severity. Diagonal cracking patterns and partial loss of plaster cover were visible at stairwell landing walls, with exposed masonry units consistent with localized in-plane infill distress. Debris accumulation on stair treads increased with each successive landing. Door frames at this level remained largely intact, though minor racking distortion was suggested by gap formation at frame corners. Visible stair structural elements appeared to maintain their overall geometric integrity throughout this zone. These observations were generally consistent with visual damage characteristics commonly associated with the **Life Safety (LS) performance level** described in ASCE 41-17, Section 2.3.1.2 and Table 2-3 (ASCE 2017).

**Figure 2:** Intermediate story level demonstrating progressive in-plane shear cracking, minor plaster spalling, and initial debris accumulation on stair treads.

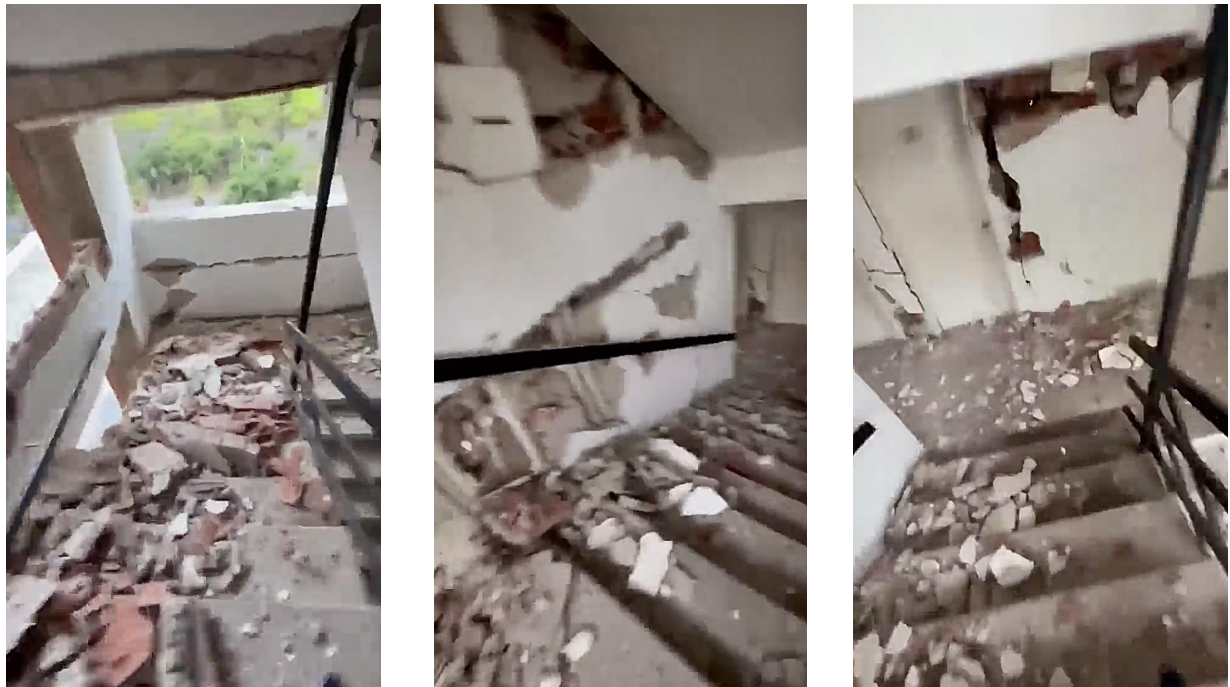
A pronounced escalation in damage severity was observed at the lower story levels. Video stills documented prominent vertical cracking extending over significant portions of the stairwell infill walls, accompanied by large-scale plaster loss and exposed brick units on both wall faces, suggesting out-of-plane instability or loss of continuity within portions of the infill panels. Heavy debris accumulation covered stair treads and landing slabs. Partial breach of stairwell enclosure walls was visible, with daylight penetration through damaged infill panels suggesting substantial loss of wall continuity. These observations were generally consistent with severe nonstructural and infill damage approaching conditions associated with the **Collapse Prevention (CP) performance level** described in ASCE 41-17, Section 2.3.1.3 and Table 2-3 (ASCE 2017); however, the available visual evidence was insufficient to establish the overall structural performance level.

**Figure 3:** Lower story levels showing severe out-of-plane infill panel distress, large-scale plaster loss, and extensive debris accumulation on landing slabs.

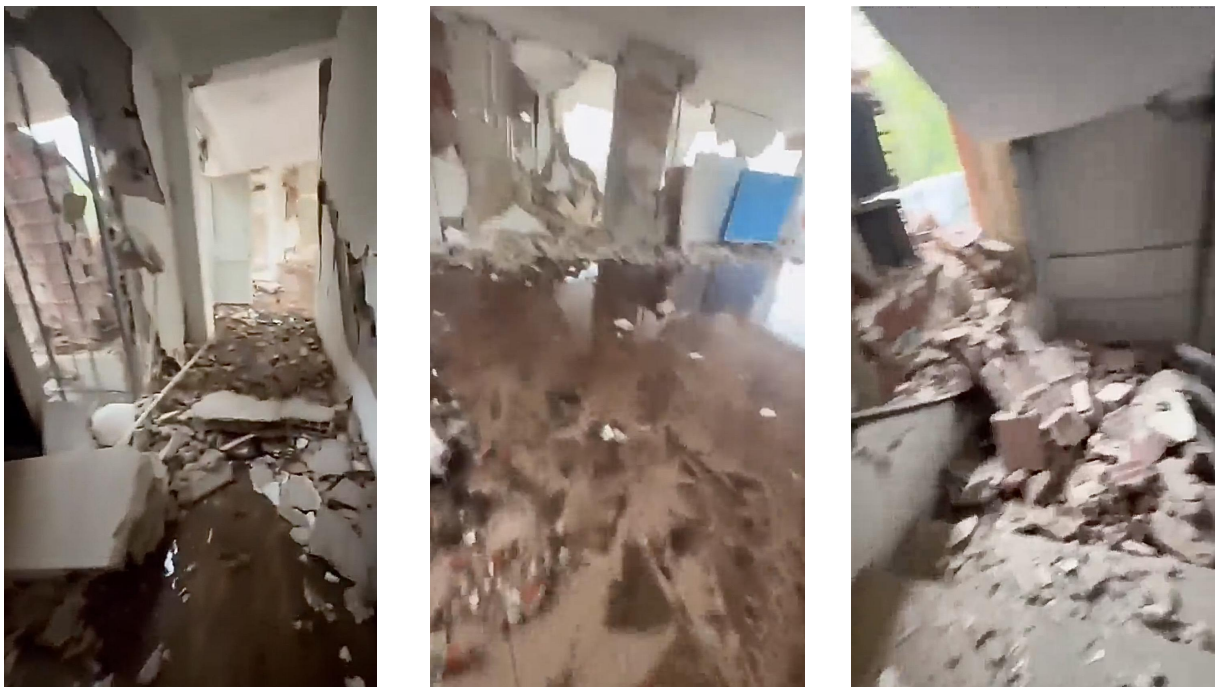
Video stills captured at the ground-floor level documented the most severe damage observed throughout the occupant's descent. Extensive damage and localized loss of masonry infill walls were evident within the visible ground-level areas, with unreinforced masonry units dispersed across floor surfaces and extending to visible exterior areas, consistent with both in-plane shear distress and out-of-plane instability mechanisms. RC frame elements, including visible columns and beams, appeared to have retained their geometric alignment, suggesting an infill-dominated damage pattern rather than visible evidence of global collapse of the RC frame system. Nonstructural systems, including partition walls, ceiling elements, and interior finishes, were extensively damaged.

The observed ground-story infill damage represented severe damage to nonstructural components, with observed conditions approaching damage states associated with extensive nonstructural damage conditions described in ASCE 41-17, Section 2.3.1.3 and Table 2-3 (ASCE 2017); however, the apparent integrity of visible RC frame members

precluded a definitive assessment of the primary structural performance level based solely on available visual evidence. The occupant's descent was obstructed at the basement stair entry, which was found impassable due to debris accumulation, preventing visual assessment of below-grade conditions.

**Figure 4:** Ground-floor level and basement stair entry showing near-total masonry infill failure, heavy structural debris obstruction, and standing water from damaged MEP utilities.

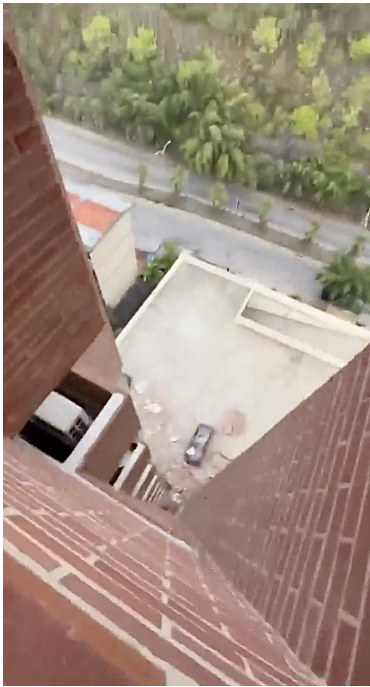
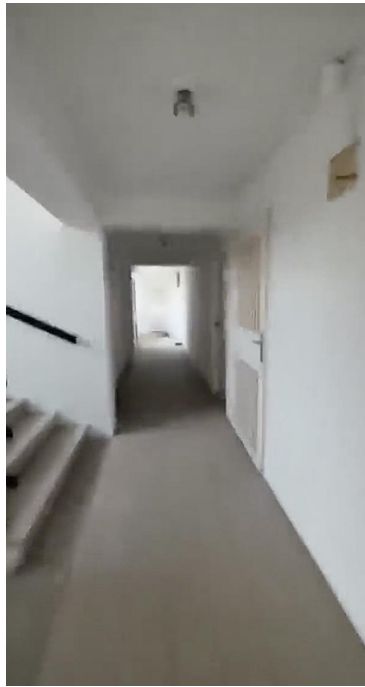
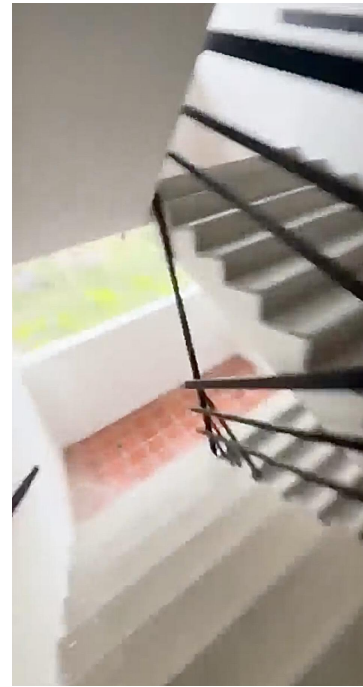
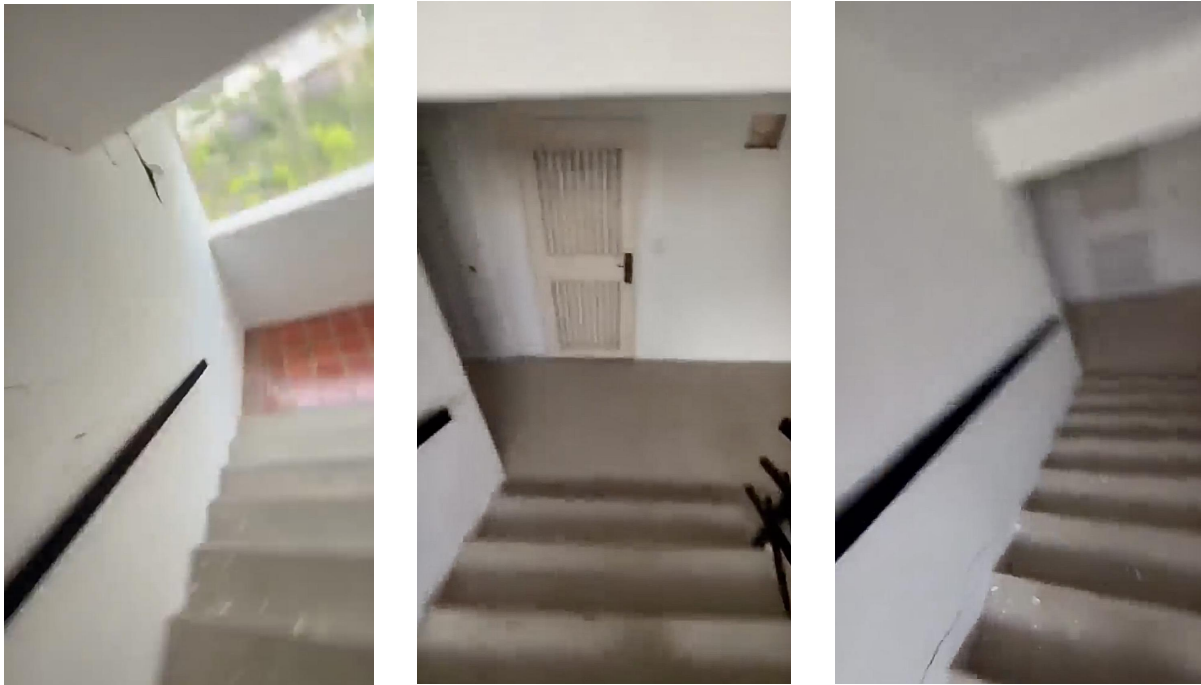
**Figure A-2:** Representative visual observations from the upper stories. The observed conditions are generally consistent with damage characteristics commonly associated with the Immediate Occupancy (IO) performance level defined in ASCE/SEI 41-17: (a) exterior view showing intact brick masonry; (b) corridor with intact wall finishes and floor surfaces free of visible debris; (c) unobstructed stairwell enclosure; (d) stairwell view showing a single hairline crack at the wall-to-slab interface; (e) door frames appearing plumb, with no visible evidence of significant distortion; and (f) stairwell landing free of visible debris accumulation

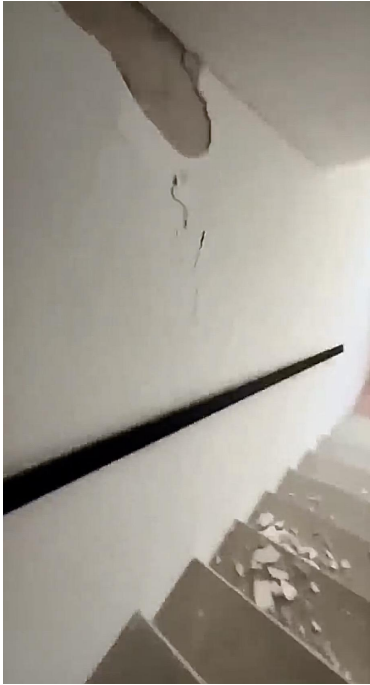
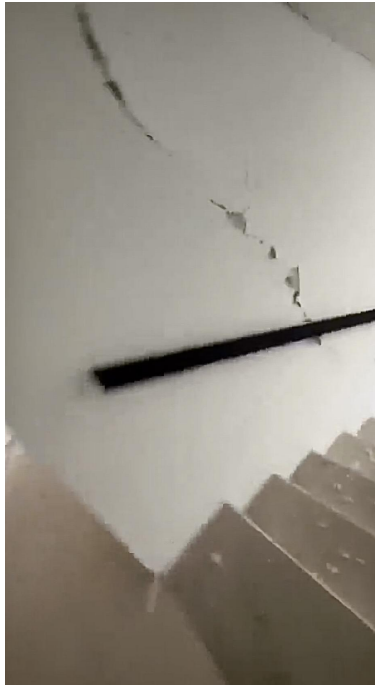
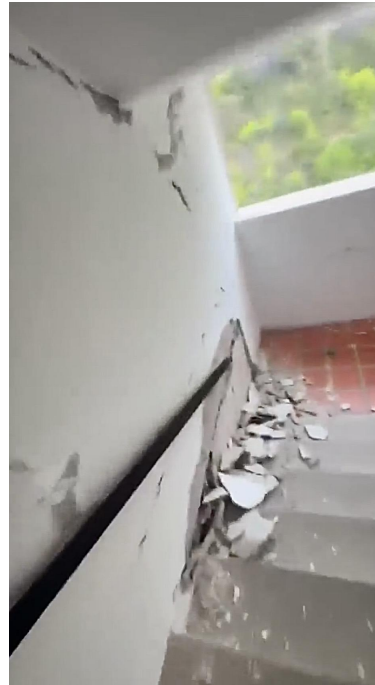
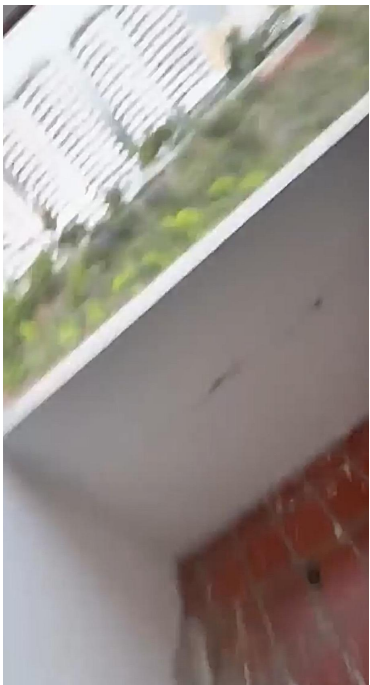
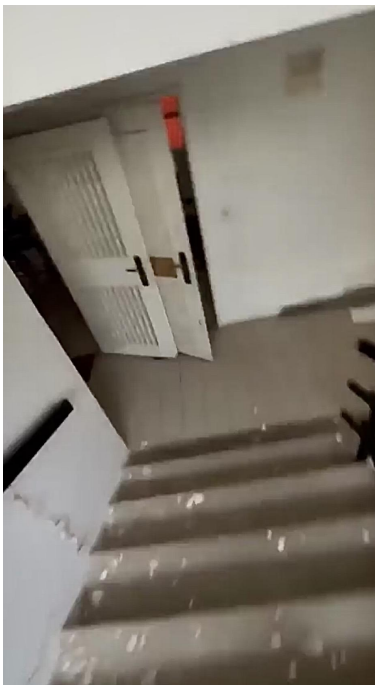
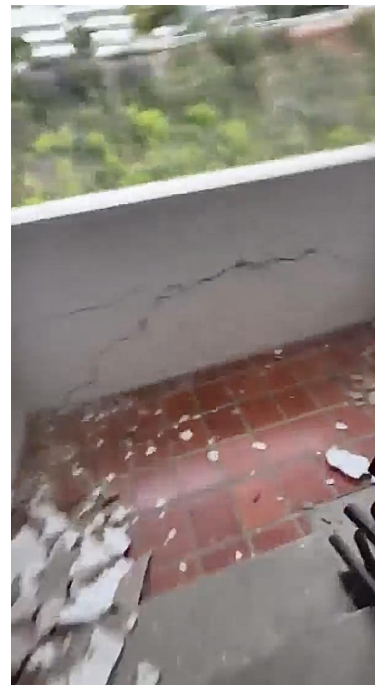
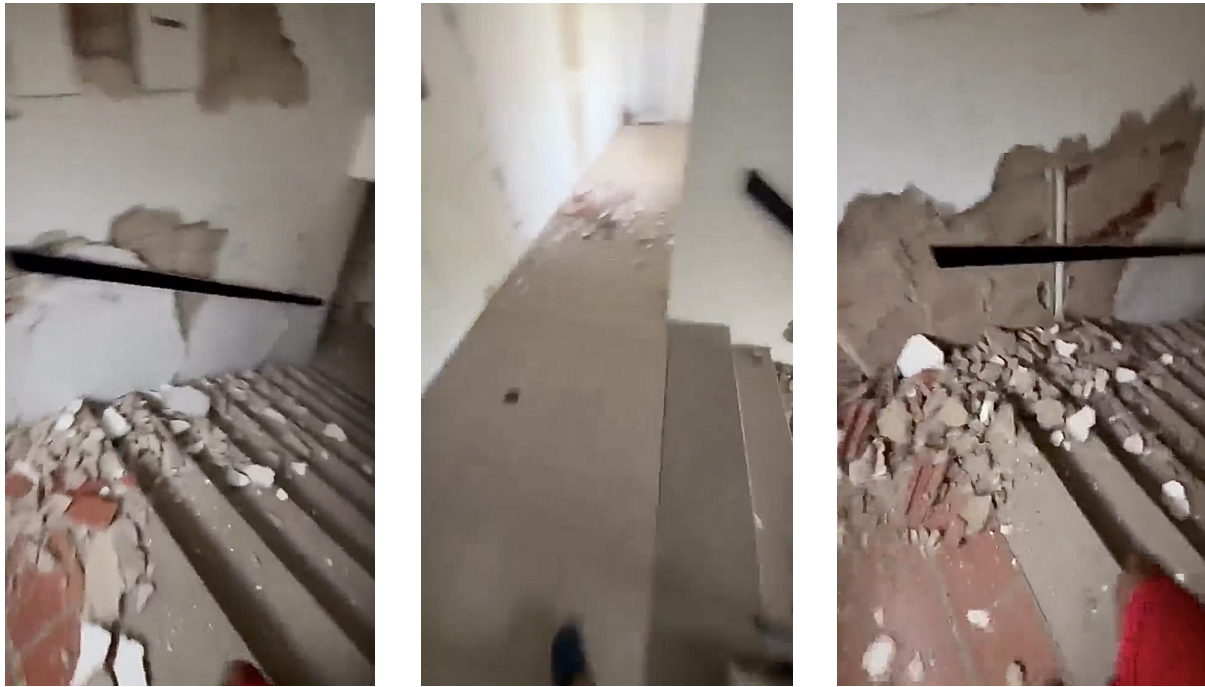
**Figure A-3:** Representative visual observations from the intermediate stories. The observed conditions indicate a progressive increase in damage severity compared to the upper stories, generally consistent with damage characteristics commonly associated with the Life Safety (LS) performance level defined in ASCE/SEI 41-17: (a) diagonal cracking and plaster spalling at stairwell landing walls, exposing the underlying masonry infill; (b) close-up view of extensive diagonal shear cracking in the masonry infill wall; (c) significant accumulation of masonry debris on stair treads and the landing; (d) view from the intermediate landing showing progressive cracking of the stairwell enclosure walls; (e) minor racking distortion visible at the corners of the door frame; (f) overall view of the stairwell illustrating the downward progression of damage; (g) increased accumulation of masonry debris on the stair treads; (h) corridor with accumulation of masonry debris; and (i) significant plaster spalling exposing the underlying masonry infill, accompanied by substantial accumulation of debris on the stairway.

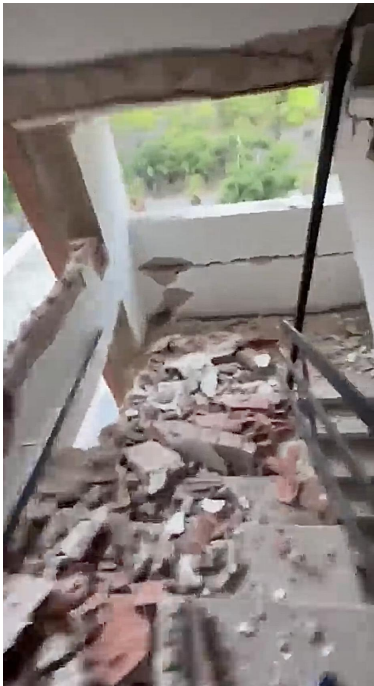
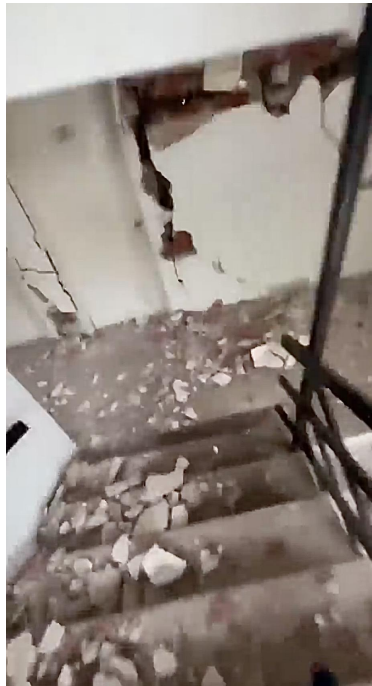
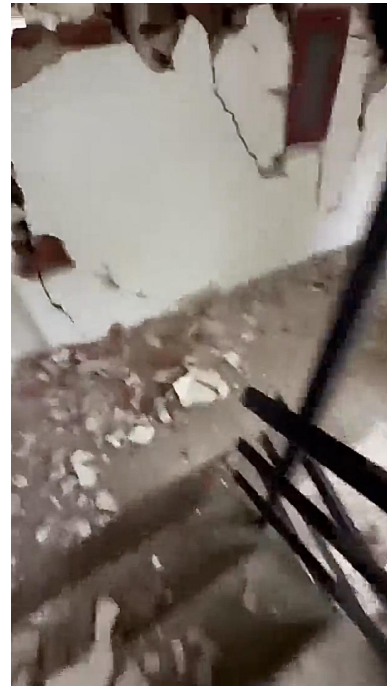
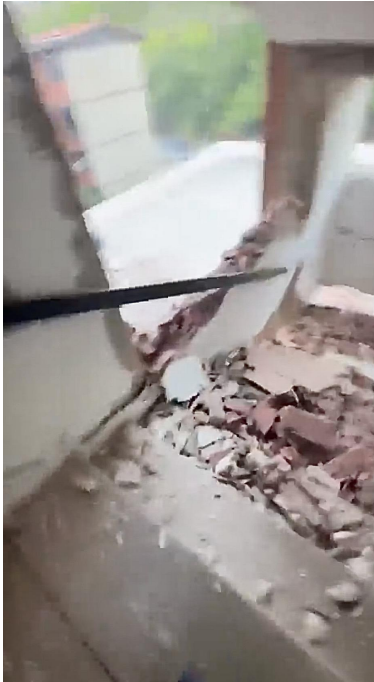
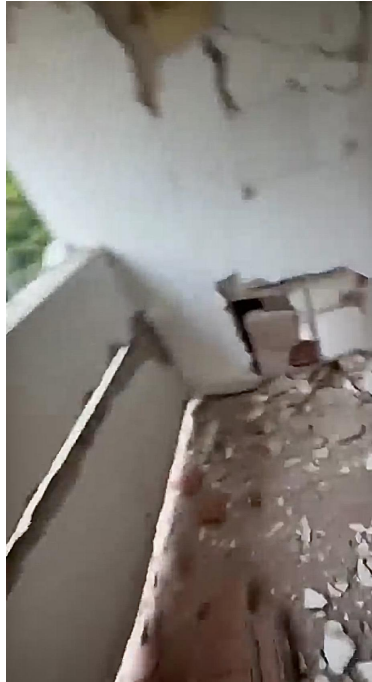
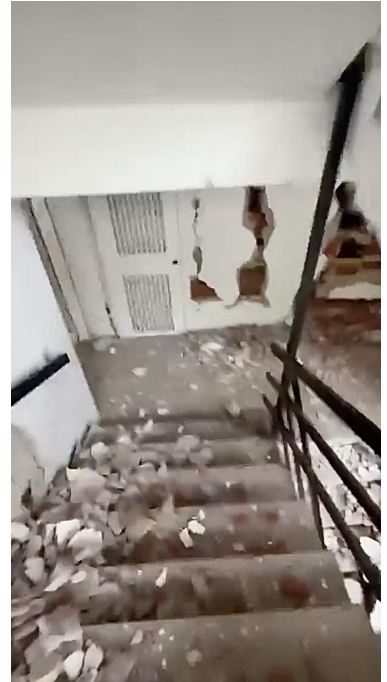
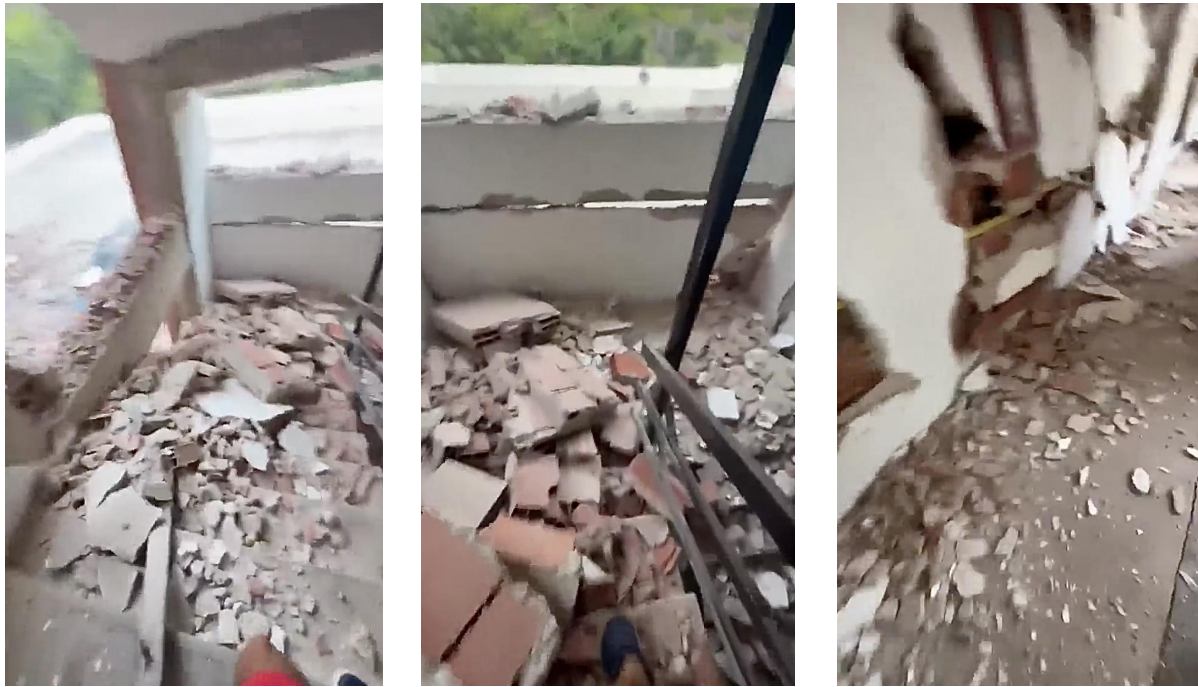
**Figure A-4:** Representative visual observations from the lower stories. The observed conditions demonstrate a pronounced escalation in damage severity compared to intermediate stories, generally consistent with severe nonstructural and infill damage approaching conditions associated with the Collapse Prevention (CP) performance level defined in ASCE/SEI 41-17: (a) Extensive collapse and loss of continuity of unreinforced masonry (URM) infill walls within the stairwell enclosure, with large portions of wall panels no longer intact; (b) and (c) wide vertical separation cracks within the corridor masonry infill walls, likely associated with seismic-induced incompatibility between the lateral deformation demands of the structural frame and the brittle response of the URM infill panels. Progressive frame–infill separation, combined with out-of-plane instability and localized dislodgement of masonry units, resulted in significant degradation of infill wall integrity, accompanied by cracking around door openings and separation between infill walls and surrounding frame elements; (d) extensive failure of stairwell enclosure walls with progressive loss of wall continuity across multiple stories, exposing exterior openings and adjacent building spaces; (e) widespread cracking, spalling, and partial detachment of masonry infill and finish materials at the lower levels; (f) similar conditions to those observed in (a) and (b), including severe deterioration and loss of continuity of URM infill walls; (g) complete failure of portions of the stairwell enclosure walls, resulting in significant loss of enclosure integrity; (h) substantial accumulation of masonry debris obstructing stair treads and landing slabs, limiting accessibility and indicating severe localized infill failure; and (i) conditions similar to those described in (a), showing extensive collapse and loss of continuity of URM infill wall panels.

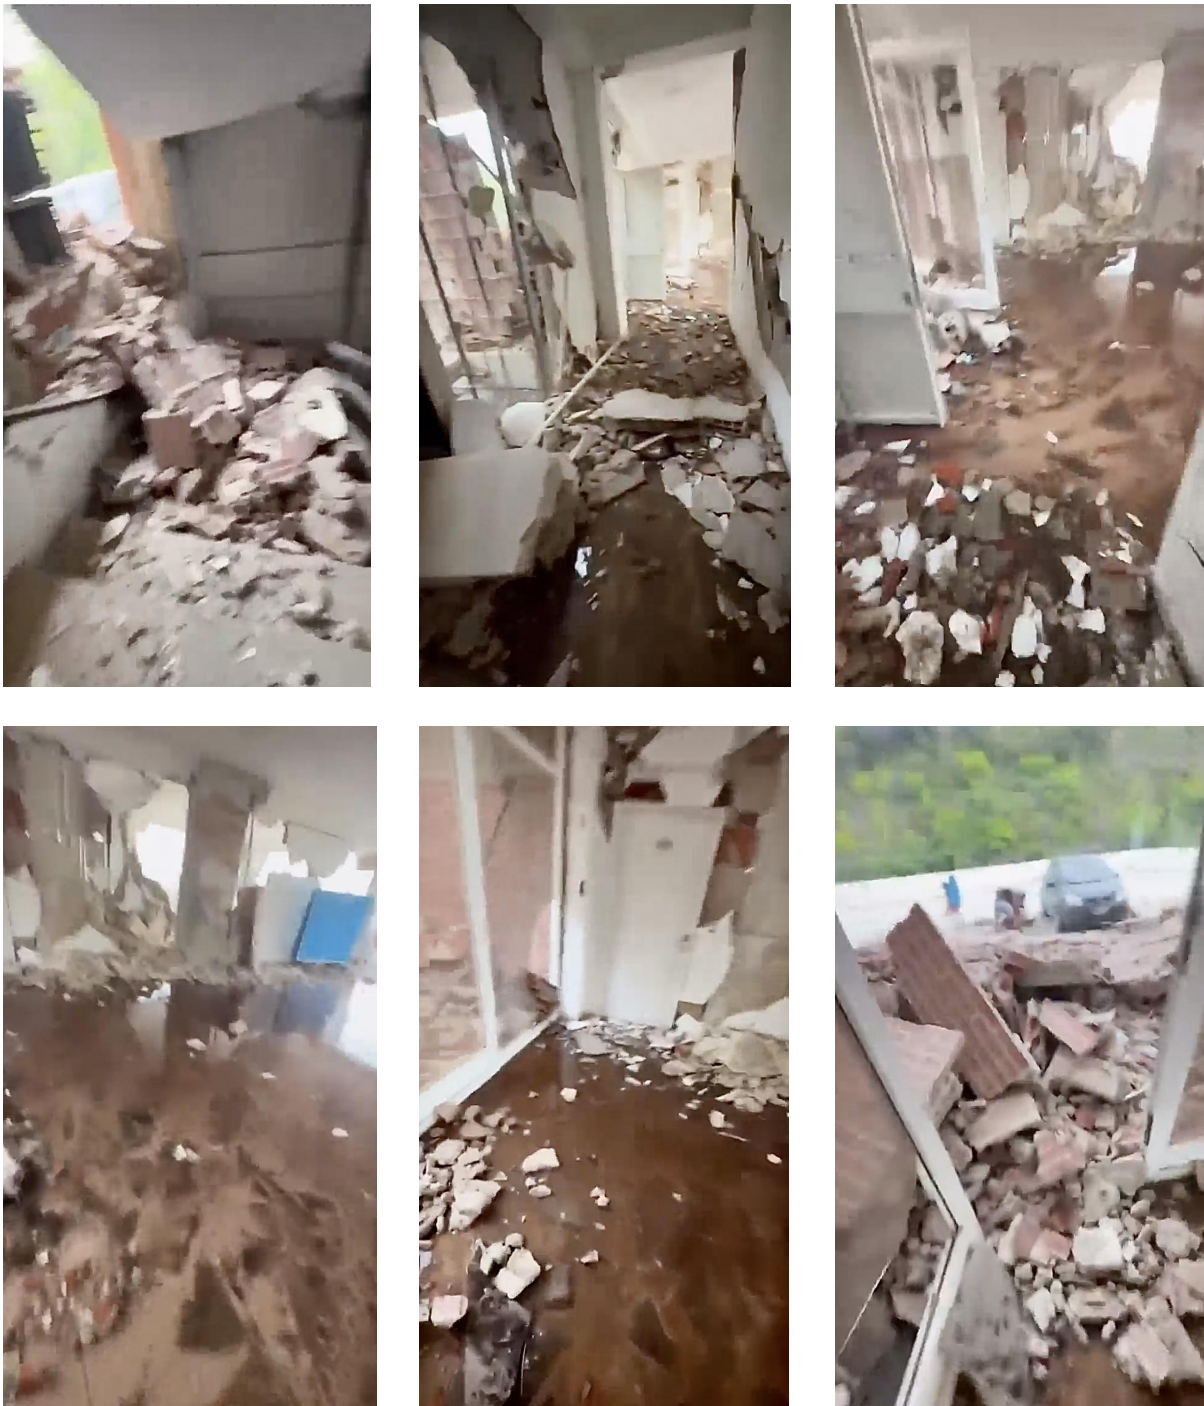
**Figure A-5:** Representative visual observations from the ground level. The observed conditions document the most severe damage encountered during the survey, characterized by extensive failure of unreinforced masonry infill walls consistent with apparent soft-story response mechanisms, while visible
