# **Seismic Damage Assessment and Soft-Story Response Mechanisms in a Reinforced Concrete Mid-Rise Building Following a Doublet Earthquake Sequence**

Lessons Learned for Post-Earthquake Structural Assessment and Seismic Resilience

**June 24, 2026 | Venezuela Seismic Event**

**July 2026 | Technical Report**

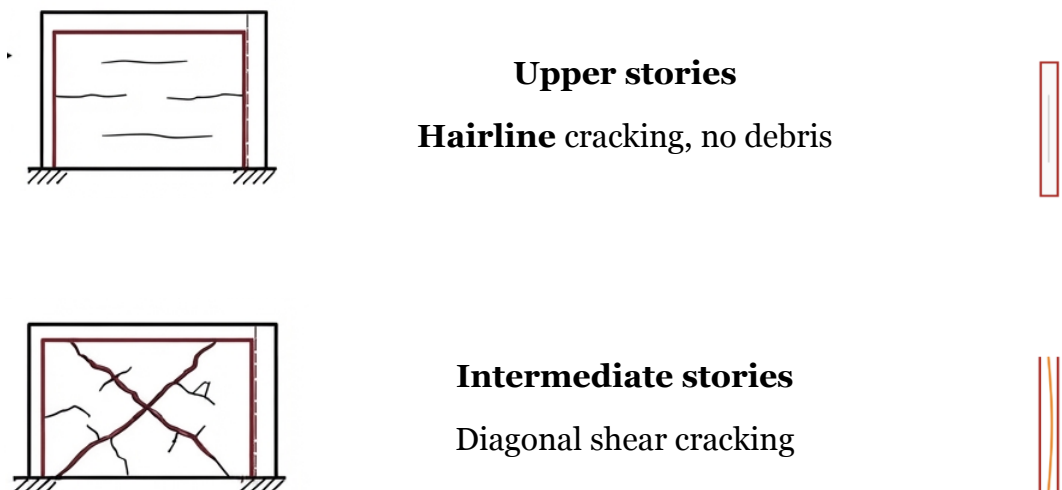
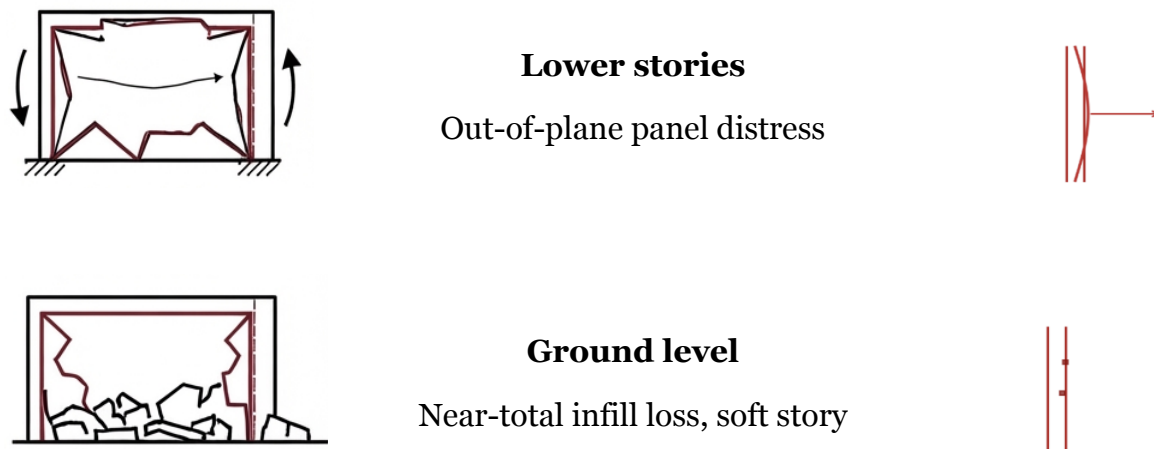
The influence of cumulative story shear should be considered independently of the soft-story irregularity discussed in Section 4.2. Even in a structurally regular building without stiffness discontinuity, the ground story would sustain the maximum shear demand. In the subject structure, the soft-story condition amplified this inherent vulnerability by further concentrating inter-story drift at the ground level, contributing to a compounding failure mechanism in which maximum force demand and maximum deformation demand coincided at the same story.

**Figure 6:** Conceptual relationship between story level, cumulative seismic demand, and observed infill damage progression (based on ASCE 2022).
